Manhole Inspection Summary

Manhole # S11Y__004MH

Insp Date: **12/10/08 12:26 PM**

Location Address: **S. Caton Ave exit 48**

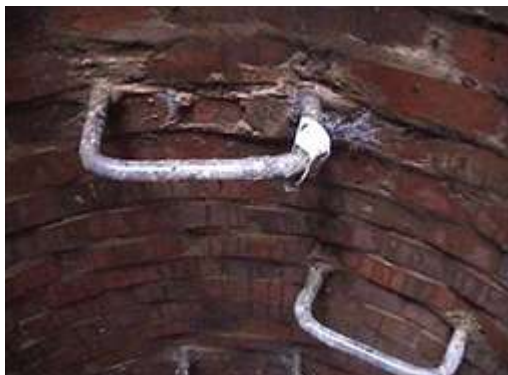
Defect 5

Steps Count: **9** Missing: **0** ☒ **Corroded**

corroded steps

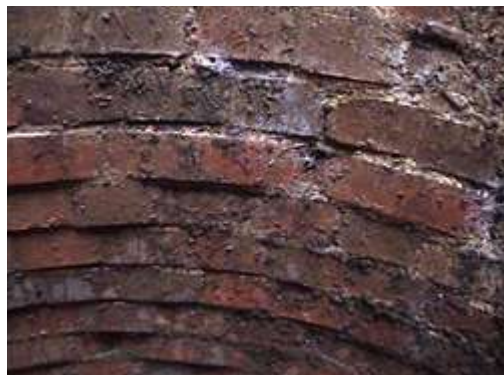
Defect 4

Condition: ☐ Sound ☐ Cracked ☒ **Root Intrusion** ☐ Loose Brick ☐ Deteriorated

Infiltration: ☐ None ☐ Joint ☐ Cracks ☐ Mortar ☐ Roots ☒ **Wall**

infiltration corbel wall

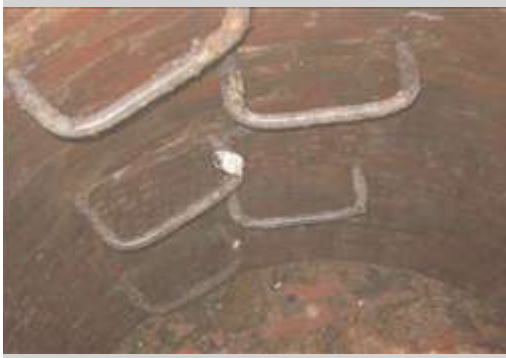
Defect 3

Surcharge ☒ **Evidence Of Surcharge** Depth: **3** (ft.) ☐ Active Surcharge Present

surcharge evidence at 3 ft

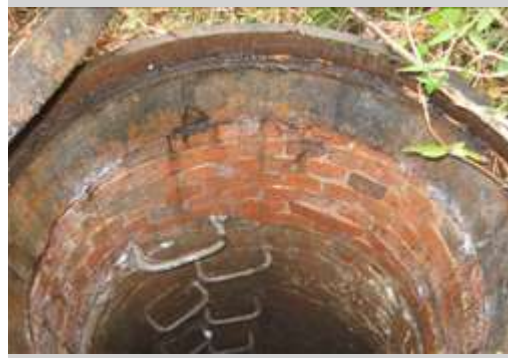
Defect 2

Frame Offset: **0** (in.) Condition: ☐ Sound ☐ Cracked ☒ **Leaks**

infiltration frame, worn

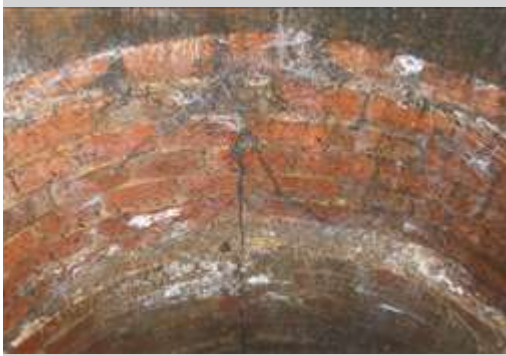
Defect 1

Condition: ☐ Sound ☐ Cracked ☒ **Root Intrusion** ☐ Loose Brick ☐ Deteriorated

Infiltration: ☐ None ☐ Joint ☐ Cracks ☐ Mortar ☒ **Roots** ☒ **Wall**

root infiltration under frame, chimney wall

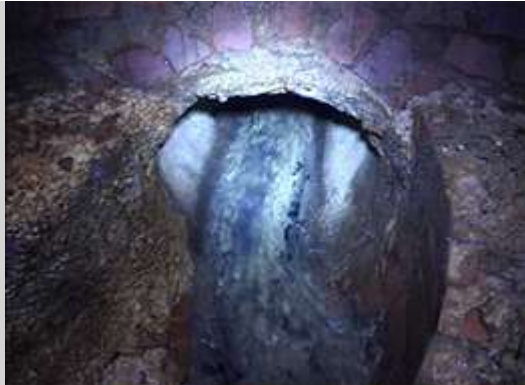
12 O'Clock Outflow

15 in. Circular Gravity Sewer
Pipe Out @ 12 O'Clock

Pipe Height: **15.6** (in.) Rod and Bar (Angled)
Pipe Material: **Clay** ☐ Pipe Lined
Invert Depth: **11.89** (ft.) Flow Characteristics: **Fast**
Deposits: ☒ None ☐ Mud ☐ Sludge ☐ Debris ☐ Grease
Silt Depth: **0** (in.) Deposits Extent:
Infiltration: **None** Pipe Seal Cond: **Sound**

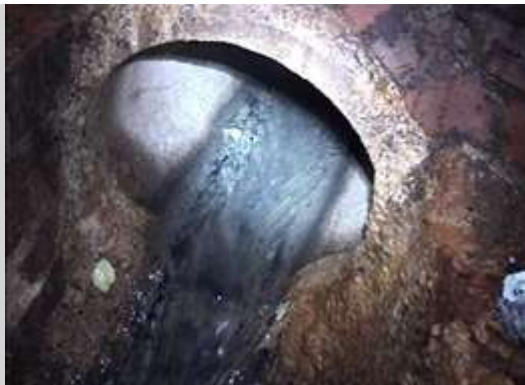
9 O'Clock Inflow

15 in. Circular Gravity Sewer
Pipe In @ 9 O'Clock

Pipe Height: **15.6** (in.) Rod and Bar (Angled)
Pipe Material: **Clay** ☐ Pipe Lined
Invert Depth: **11.61** (ft.) Flow Characteristics: **Fast**
Deposits: ☒ None ☐ Mud ☐ Sludge ☐ Debris ☐ Grease
Silt Depth: **0** (in.) Deposits Extent:
Infiltration: **None** Pipe Seal Cond: **Sound**
